An Analysis and Evaluation of the Damage and Durability Performance of Steel Belted Radial Ply Passenger Tires That Have Experienced Severe Impacts

2012-01-0795

William John Woehrle
Tire Forensics Investigations

Dennis Carlson
Carlson Engineering

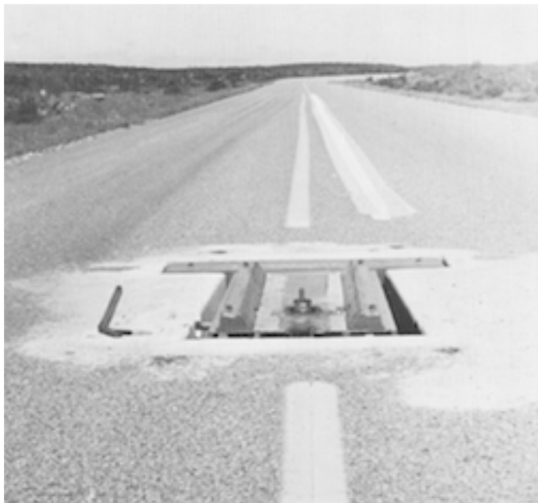
As tire company proving grounds emerged shortly after World War II, impact test facilities were typically included along with durability, treadwear, traction, ride, and handling courses. An example of such an early impact facility was the Penetration Rupture Course as shown in [Figure 1](#). It featured a machine, imbedded in the roadway, which contained a steel rod with a rounded, hemispherical head, called a rupture pin. Located immediately beyond the pin was a tripping mechanism that, when struck by the tire that had just been impacted, the rupture pin collapsed into the machine. This facilitated the testing of the front tire on the vehicle without testing or otherwise disrupting the rear tire. For this test, the rupture pin height was varied along with the speed of the vehicle, to ultimately determine the conditions under which the tire would fail. This early facility proved to be much more consistent with customer usage than a static test.

Figure 1. Penetration Rupture Course

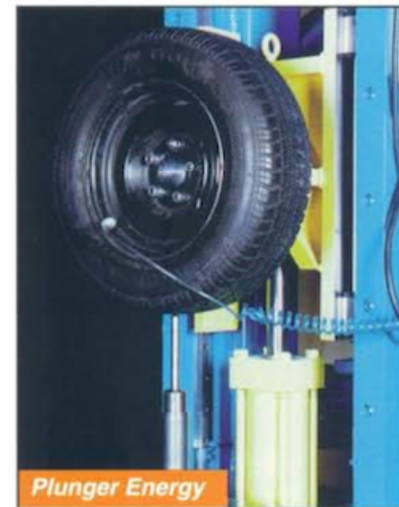
Nevertheless, for obvious practical and economic reasons, this rupture pin was ultimately incorporated in the static laboratory tests widely found in many Standards, including FMVSS 109. Such a laboratory fixture is shown in [Figure 2](#). While this type of laboratory test obviously evaluates tire strength, it is not generally considered an impact test, because this “plunger pin” is expected to travel rather slowly into the tire structure (typically 2"/minute).

Figure 2. STLSM MACHINERY DIVISION

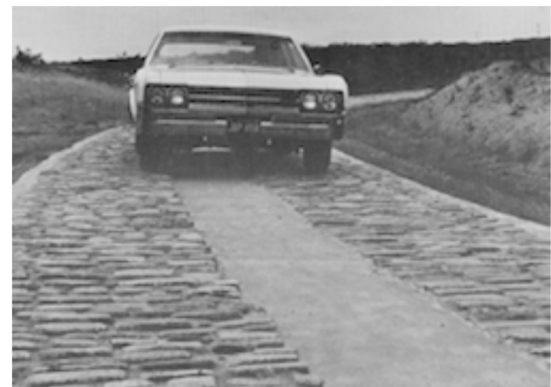
Another type of impact course that emerged with the tire proving grounds was the Belgian Block Course, as shown in [Figure 3](#). This rough cobblestone road provided an impact type of experience for the tire as well as vehicle components. It was similar to courses which existed at automotive proving grounds and provided for the evaluation of tires in a manner similar to that used by those customers.

Figure 3. Belgian Block

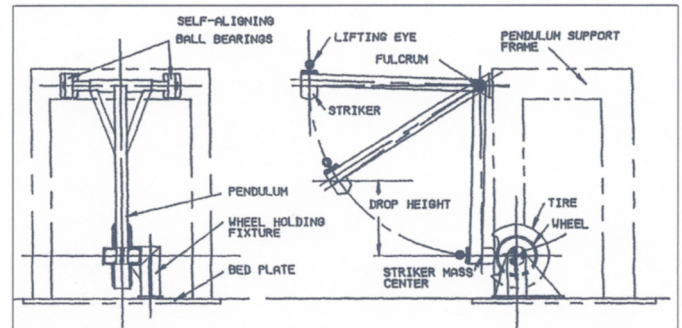
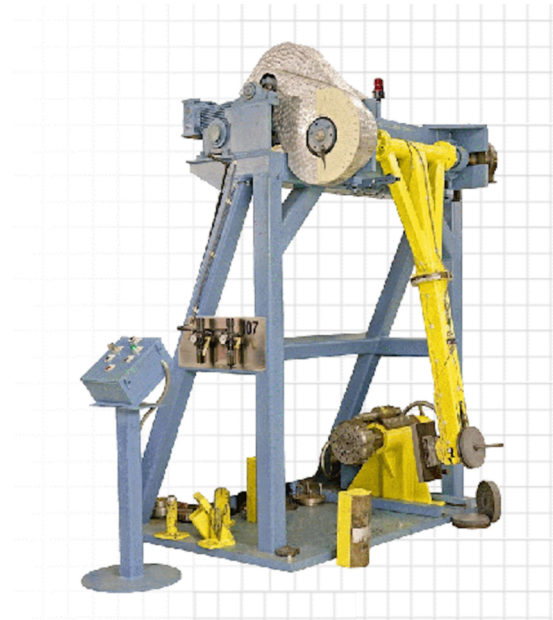
laboratory test features a striker mounted at the end of a pendulum, which swings down and strikes the tread of a tire mounted and inflated on a wheel, which is fastened and positioned statically on a test fixture. This machine is shown in [Figure 5a-5b](#).

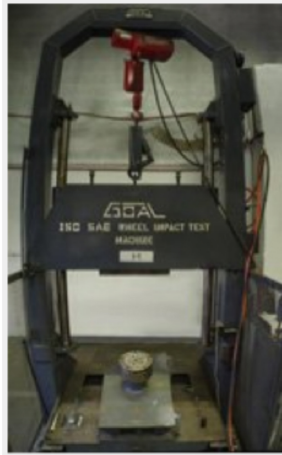
Figure 6.

A significant variation of the pendulum machine is a straight drop machine, which also is a static test of a mounted and inflated tire/wheel assembly. While there are distinct technical advantages of the pendulum test over the drop test, the latter is nonetheless widely used and has been proven to produce reliable results when care is taken and the test parameters are carefully managed. The drop test machine is shown in [Figure 6](#).

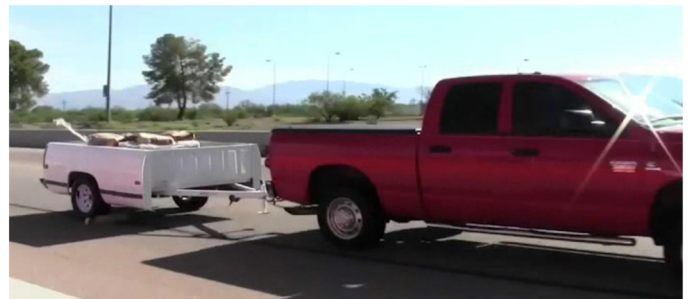
Figure 7.

The test vehicle consisted of a salvaged bed of a half ton pickup truck, complete with its solid rear axle/differential housing and with a normal leaf spring and shock absorber suspension system. A ball hitch receiver was fastened to the front of the "trailer", which was hitched to a towing vehicle consisting of another pickup truck with ball hitch offset 24" from the center of its track width. Such an offset facilitated an impact test on a single tire, with all other tires on the vehicle combination successfully avoiding the hazard. The vehicle combination is shown in [Figure 7](#).

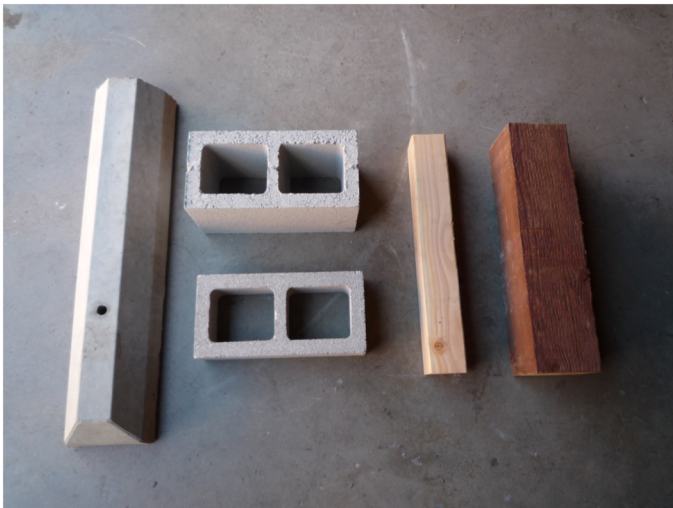
Figure 8.

This collection of impact hazards is shown in [Figure 8](#). All impact tests were run on a closed course in Tucson, Arizona.

Paintballs and tire crayon were applied to the impact hazards in order to accurately mark the impacted areas on the test tire tread surface.

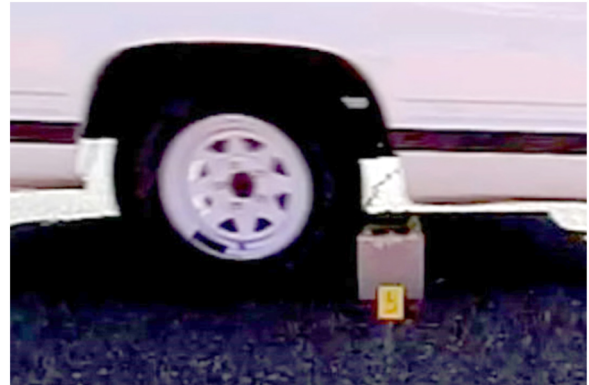
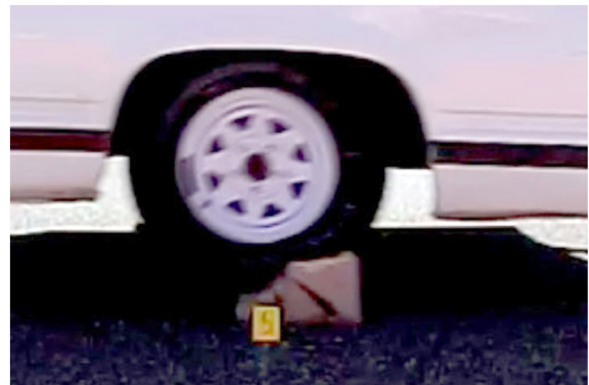
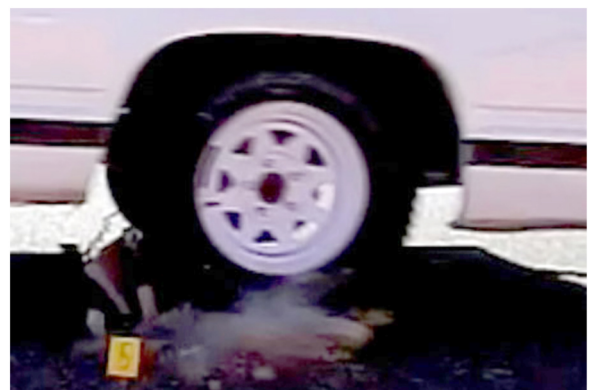
During impact test number 5, the wheel experienced a severe dent in the inboard rim flange and a slight dent in the

outboard rim flange. This rim damage led to a 13 PSI loss of inflation pressure, between the tire beads and the rim flanges, while the tire/wheel assembly continued its subsequent travel over a distance of approximately $\frac{1}{4}$ of a mile. This impact encounter is shown in [Figure 9a, 9b, 9c](#). This damaged wheel is shown in [Figure 10a-10b](#).

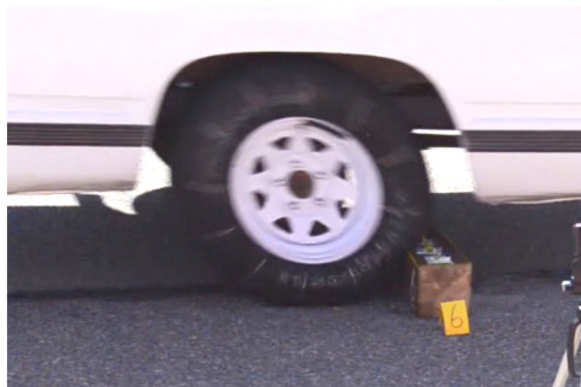
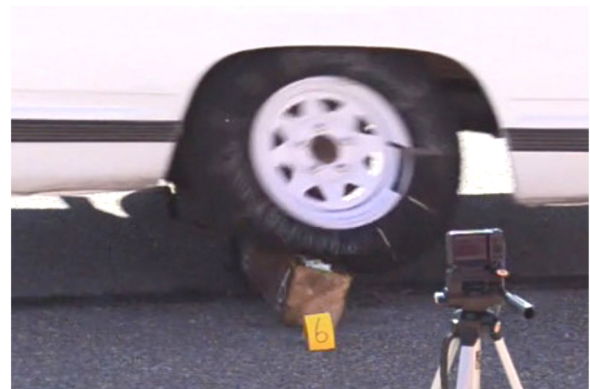
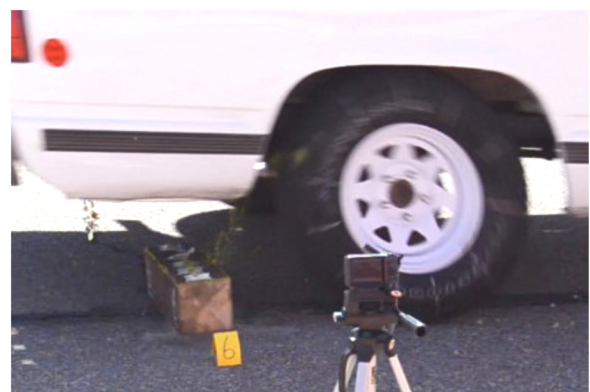
In impact test number 6, the inboard rim flange of the wheel was slightly bent, which would have probably led to a slight loss of inflation pressure between the bead and the rim flange under loaded, rolling and steering conditions. This particular impact also broke the shock absorber from its mounting on the rear axle housing. This impact encounter is shown in [Figure 11a, 11b, 11c](#), and the damaged wheel is shown in [Figure 12](#).
